ABILITY OF RADCON #7 TO MAINTAIN A
WATERTIGHT SEAL ON CRACKS FOR A FULL THERMAL CYCLE

16-18 March 1995

Prepared by
RADCRETE PACIFIC Pty Ltd

"ST LEONARDS CORPORATE PARK"
39 Herbert Street
ARTARMON

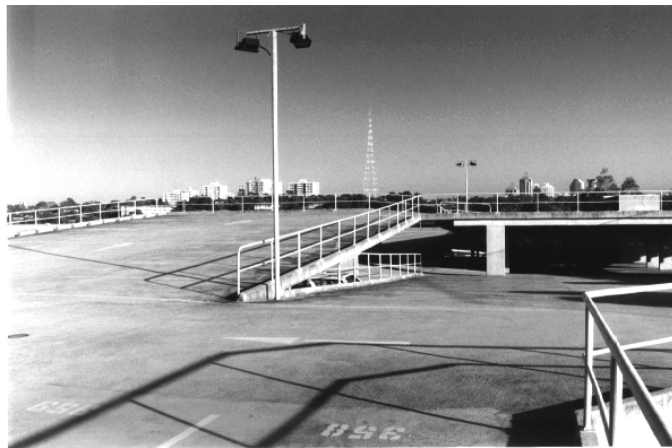
TOP CAR PARK DECK

Site Notes: This site is a four level car park with normally reinforced decks. It was Radcon #7's first major car park sealing job undertaken with severe leakage evident. A total of 300 lineal metres of leaking crack ranging from 0.5 - 2.5mm in width were evident prior to treatment.

Radcon #7 was treated to the entire top level which is completely exposed. The treatment was a complete success, however some major cracks required two or three treatments to gain a 100% seal. These re-treated cracks obviously contained large voids which required additional product to bridge the cracks entirely.

It should be noted that the site had been leaking for a period of approximately 9 months prior to the Radcon #7 application. This is the reason for the extensive calcium leaching (staining) on the underside of the slab.

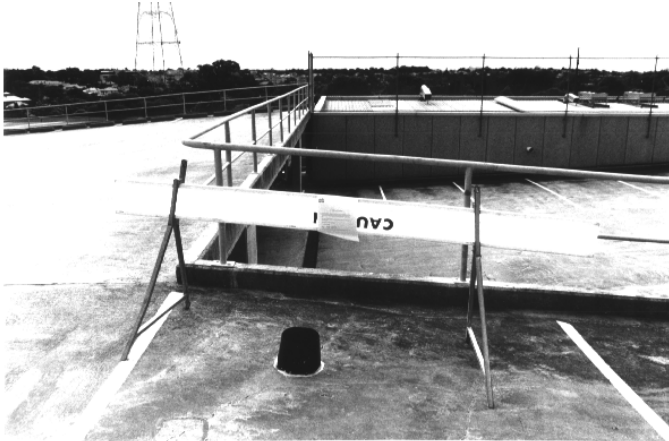
Location Shot ~ Crack #1

This crack is located on the top deck of the car park that is exposed to the weather. It was treated with Radcon #7 and has maintained a seal since the application in 1988.

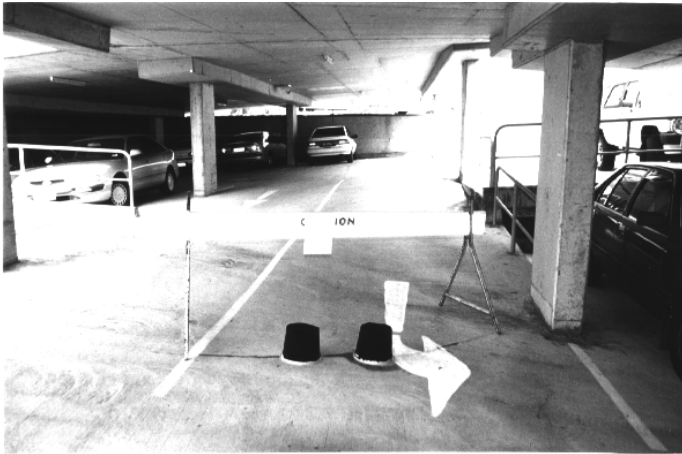
Location Shot ~ Crack 2

This crack is located on a lower level that is exposed to wind-driven rain and leaks during raining periods. No attempt has been made to waterproof this crack.

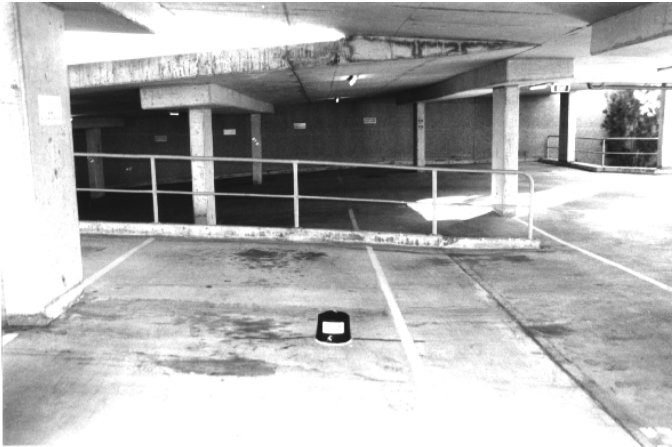
Location Shot ~ Crack #3

This crack is located on a lower level that is exposed to wind-driven rain and leaks during raining periods. No attempt has been made to waterproof this crack.
