MY THUAN BRIDGE — MEKONG RIVER, VIETNAM

BRIDGE DECK WATERPROOFING — TECHNICAL FEATURE

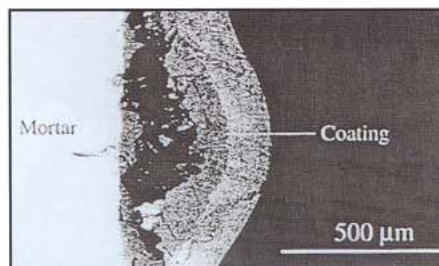
SEM MICROGRAPH SHOWING A BLISTER IN A POLYURETHANE MEMBRANE

- The membrane, which exhibited excellent adhesion to concrete and asphalt in the laboratory, is found to be bubbling up and failing on site.

- The failure is not a product or application-detailing problem - the membrane was applied to a concrete surface that contained entrapped moisture.

A perfectly sealed membrane is not a breathing surface and so, as the heat from the sun drew vapour to the top of the slab (in effect, sweating), the membrane has been blown off to the point of delamination.
