REPORT BIN 151

**INVESTIGATION OF CONCRETE CORES
(Hong Kong Highways Department)
FOR RADCRETE PACIFIC**

Investigation of Concrete Cores (Hong Kong Highways Department) for Radcrete Pacific

March 1999

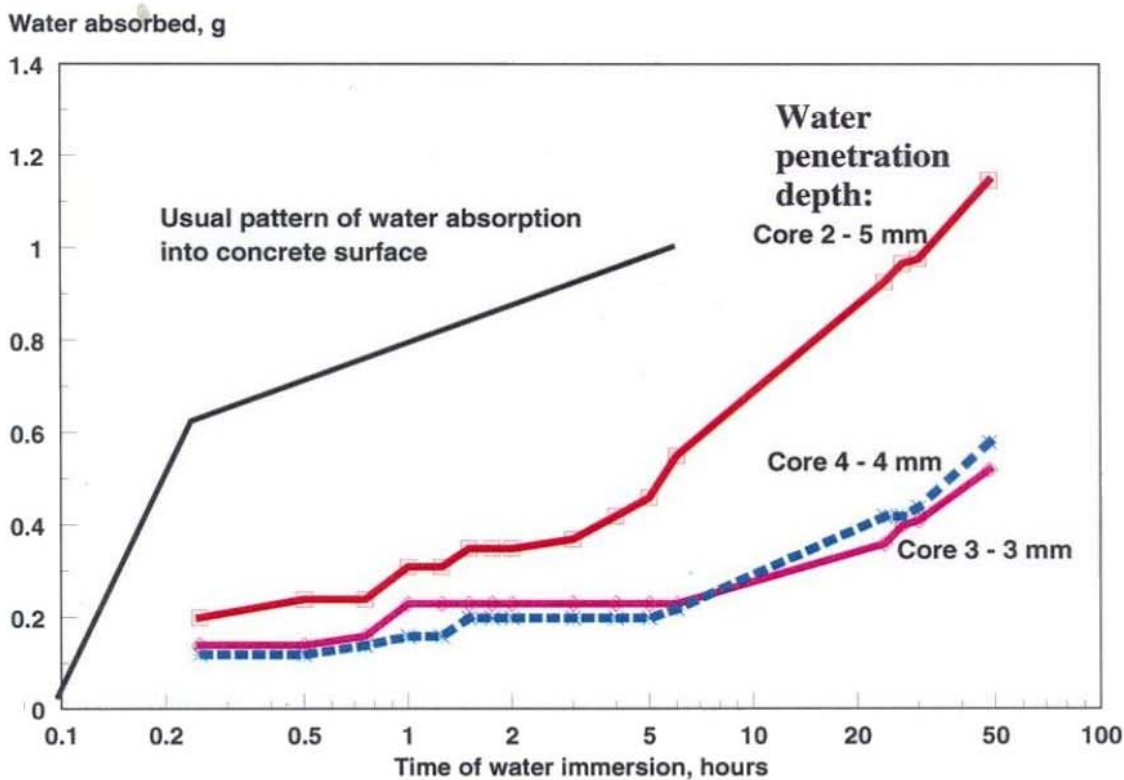
Figure 3 shows the pattern of water absorption (by weight) with time of treated cores. (It should be noted that there is a relationship between water penetration depth and absorbed water for unidirectional absorption (coated samples). If the sample were not coated, this is not applicable). A schematic pattern of water absorption of a concrete (cut surface) is also shown. The difference in the water absorption pattern suggests strongly that the treated surface act as a “membrane” against the ingress of water.

Figure 3. Water absorption patterns of treated cores

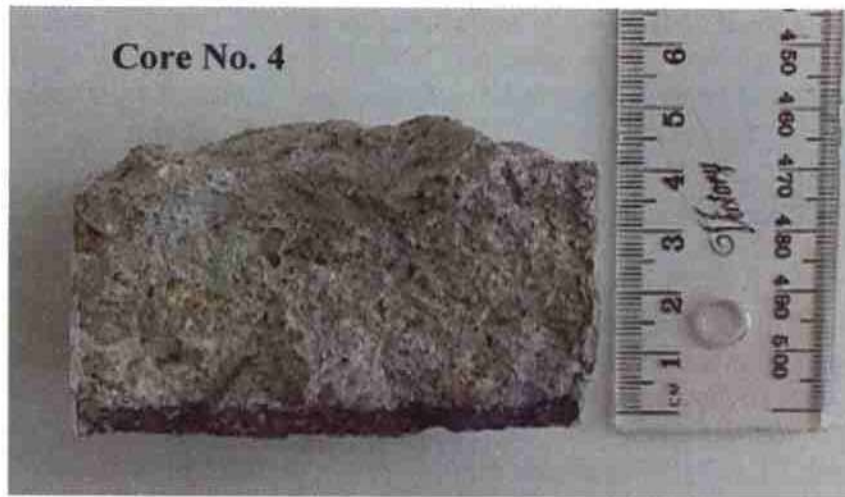
- Core No. 2 = 5 mm
- Core No. 3 = 3 mm
- Core No. 4 = 4 mm

Figure 4. Water penetration after 24 hours in Core No. 4

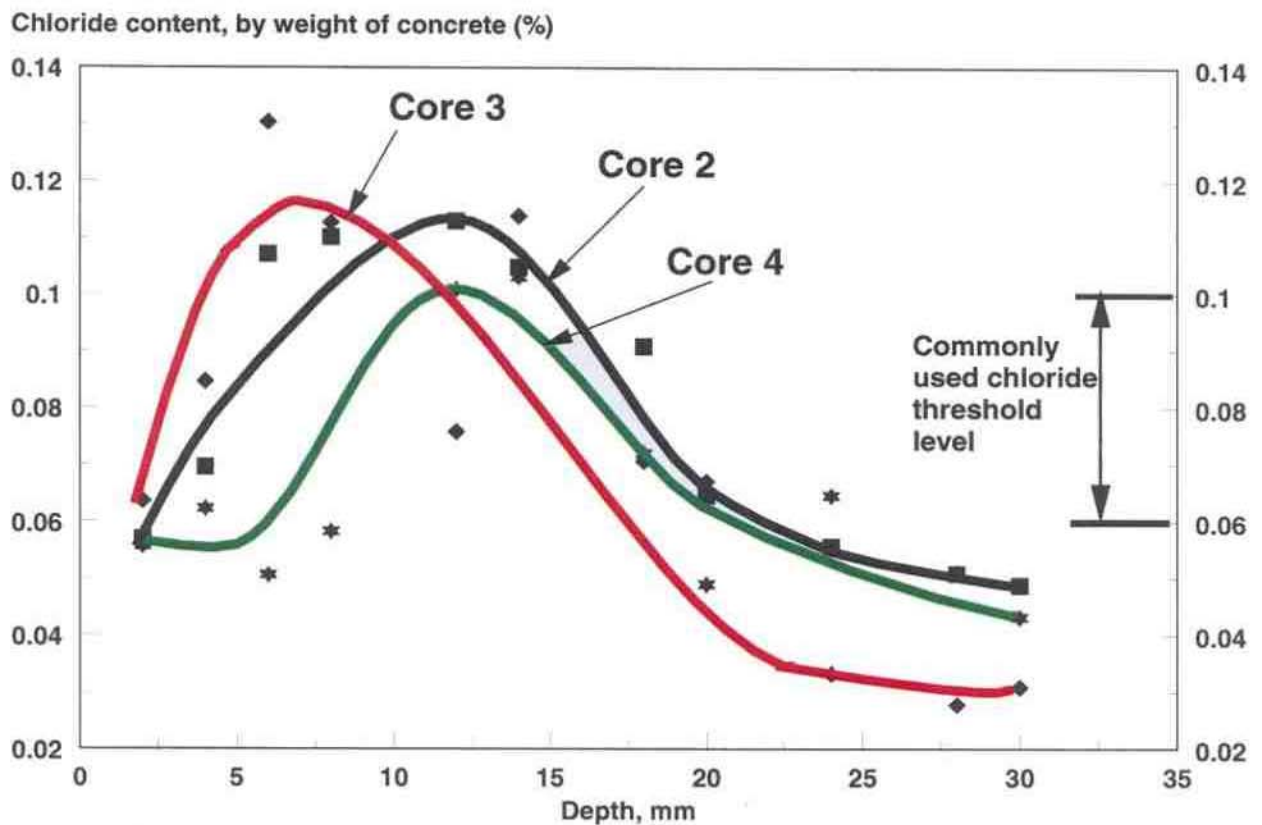
Figure 5. Chloride profiles of supplied concrete cores

The chloride patterns shown in Figure 5 denote that at a depth of 20 to 25 mm, the chloride contamination is in the range of 0.03 to 0.05% by weight of dry concrete. This range of chloride levels is well below the commonly used chloride threshold level for steel reinforcement corrosion. This implies that corrosion of steel reinforcement is not expected in this structure if the cover is 25 mm or more.

Figure 5 suggests further that the Chloride concentration at the surface layer is very low (commonly in the range of 0.5 to 1% by weight of concrete). The “driving force” for chloride penetration, ie. concentration gradient, is expected to be less for Radcon Formula #7 treated surface concrete.

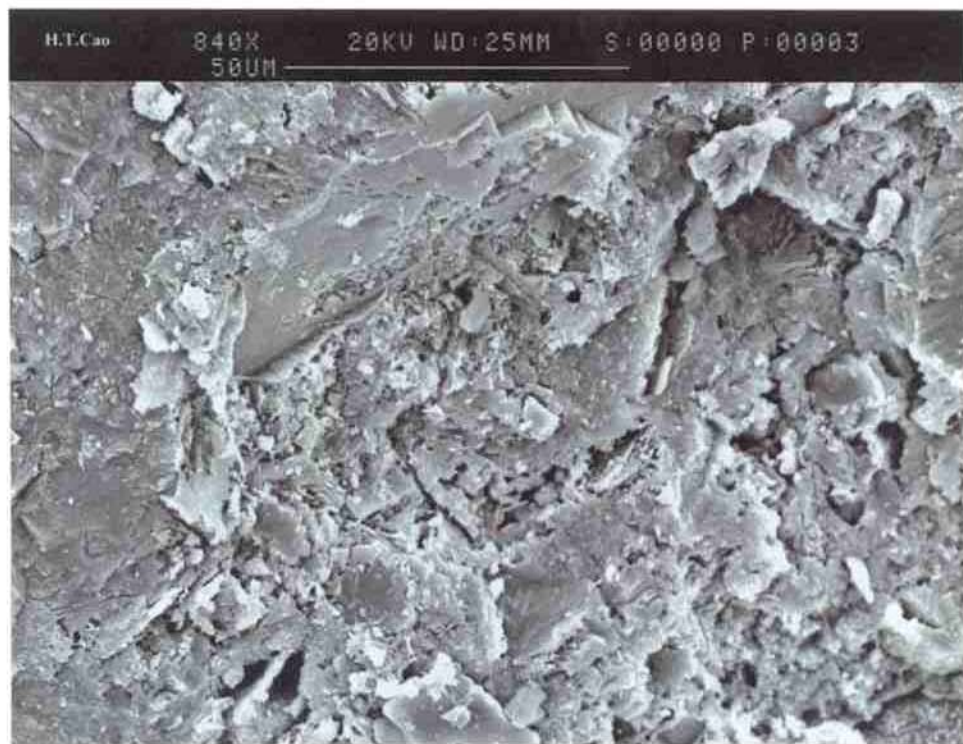
Figure 8. Amorphous “glassy looking” very low calcium – silicate compound (product of Radcon Formula #7) found in the first few mm from treated surface

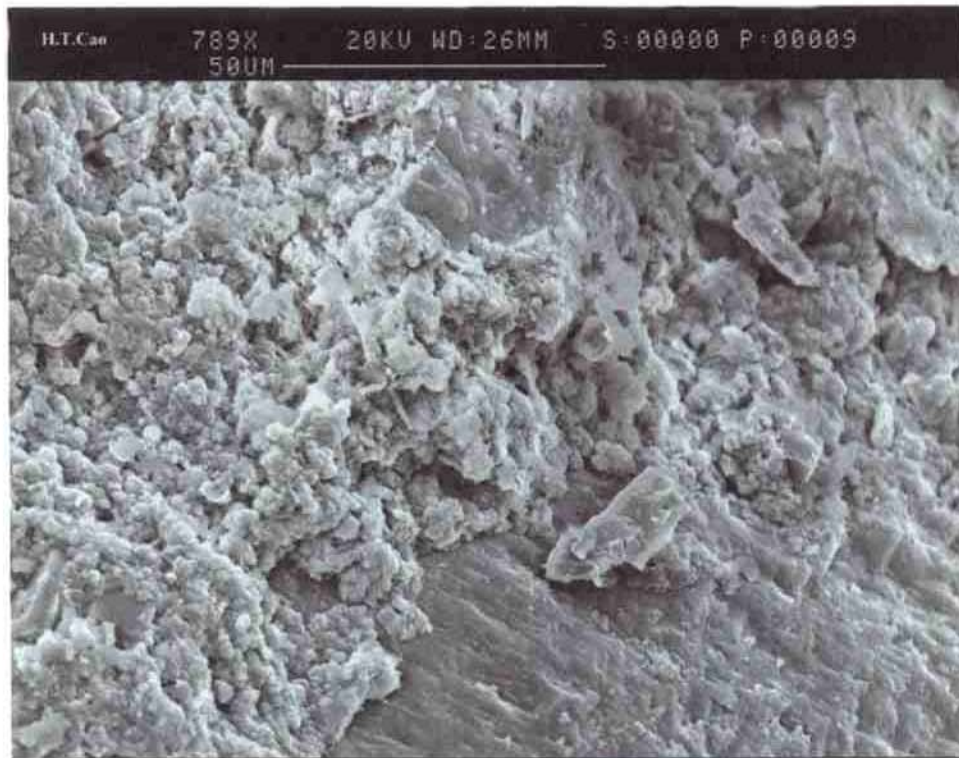
Figure 9. Relatively high calcium – silicate compound (product of Radcon Formula #7) found in at depth about 10 mm in the core (ratio of Calcium to silica ~ 1 : 1)

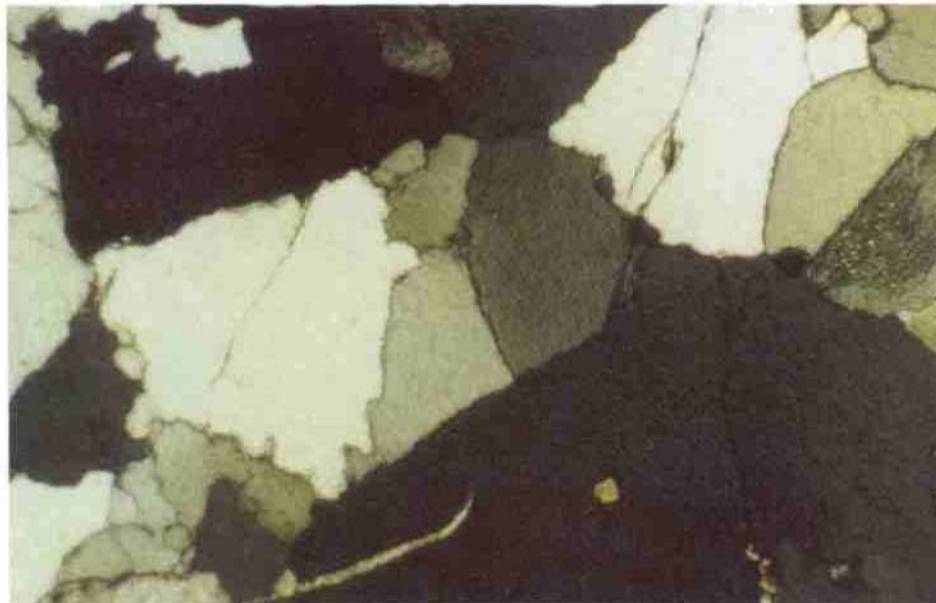
Figure 12. Typical thin slide micrograph of concrete core No3 showing no evidence of AAR.

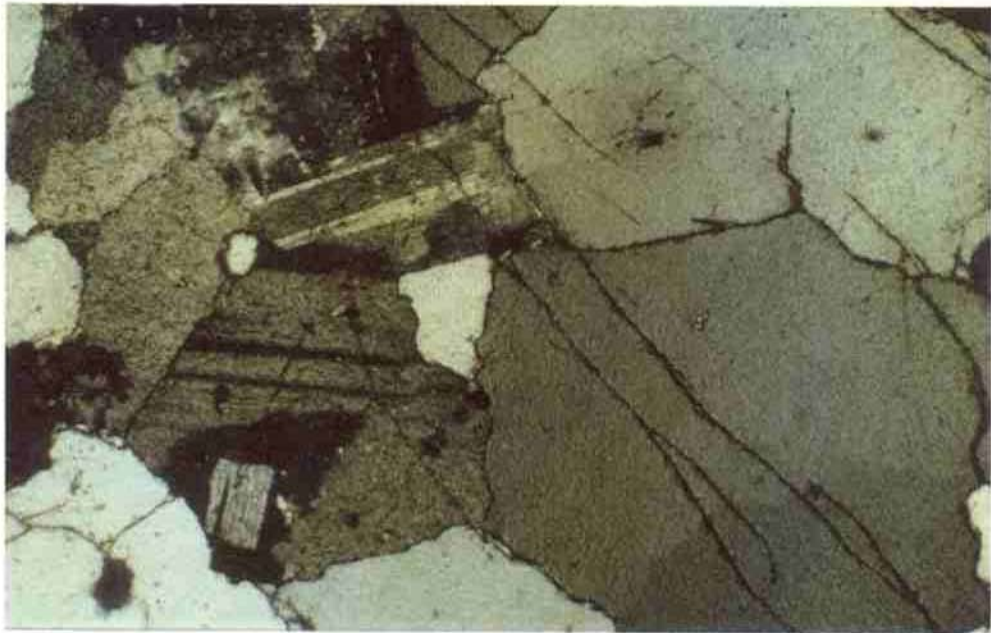
Figure 13. Typical thin slide micrograph of concrete core No4 showing no evidence of AAR.

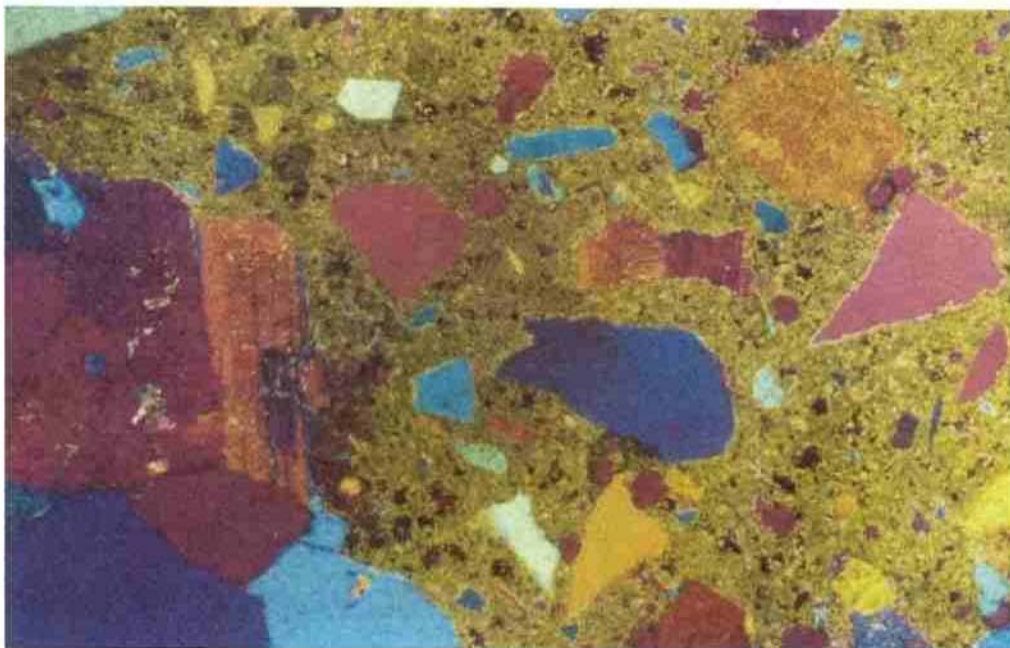
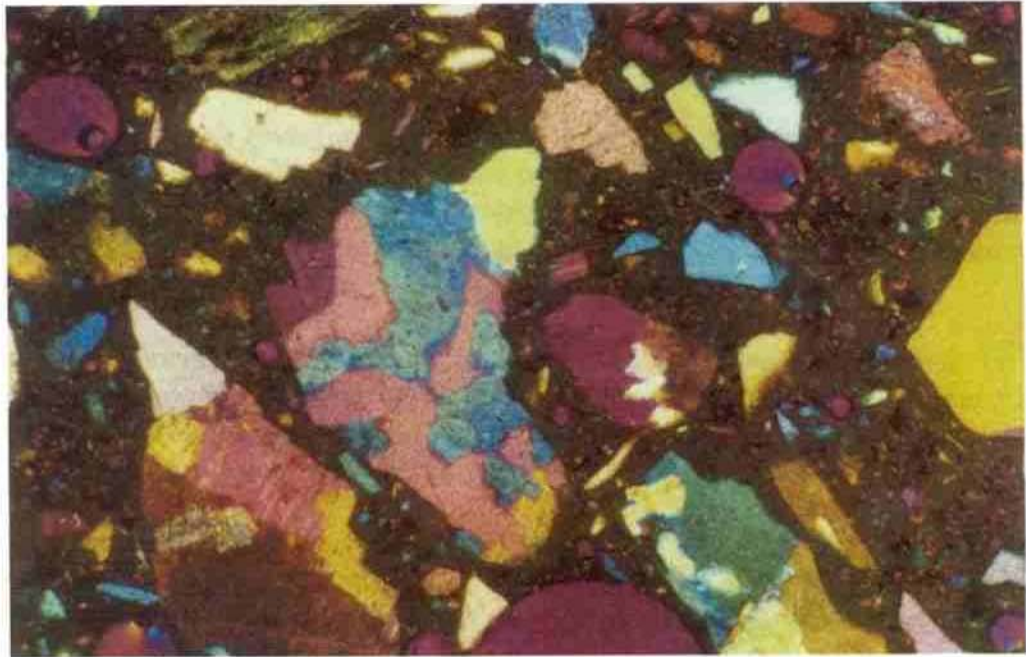
Some micrographs obtained during the examination of the thin slide samples by optical microscopy are shown in Figures 11 to 16. As noted previously, there was no evidence of AAR.

Figure 14. Some thin slide micrograph of concrete core treated with Radcon Formula #7

Figure 15. Some thin slide micrograph of concrete core treated with Radcon Formula #7

Figure 16. Some thin slide micrograph of concrete core treated with Radcon Formula #7
